Ray's Well Testing Service Inc. 4853 Vine Hill Rd, Sebastopol Ca 95472 **Phone** 707 823 3191 **Fax** 707 317 0057 **Lic#** 903708

REPORT #: 11759-1 - By: Matt Owens	DATE OF TEST: 3/30/20
CUSTOMER NAME: Anna J. Jensen	CONTACT:
AGENT NAME: Karl Bundesen - Century 21	CONTACT: 707 769 9000
PROPERTY ADDRESS: 3501 Middle Rd, Petaluma CA 94952	SENT TO: karl.bundesen@bundesen.com

LOCATION OF WELL:	Agricultural Well - Across creek from domestic well	
TYPE OF WELL:	Hand Dug	
DEPTH OF COMPLETED WELL:	10 Feet	
DIAMETER OF WELL CASING:	4' 3" I.D. Brick Lined	
SANITARY WELL SEAL (PLATE SEAL AT OPENING OF WELL CASING): No		
ANNULAR SEAL (IN-GROUND SEAL OF BOREHOLE): No		
PUMP HP AND TYPE: 1.	5 HP 230V Horizontal Jet, 1.25" Sch. 40 pipe, J15S	
DEPTH OF PUMP SUCTION: 9.	8 Feet

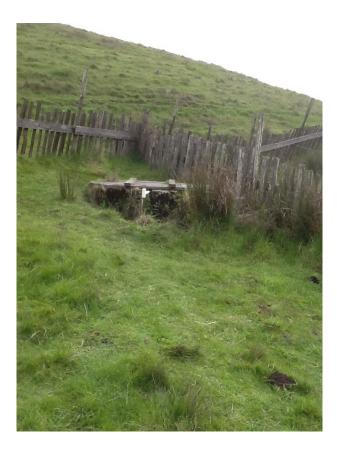
Well Pump

4. The well pump pressurizes the 120 gallon galvanized pressure tank. The operating pressure range is set 60 to 80 PSI. This system

3. The well pump is not protected from dry running. Recommend installation of a level switch to protect the pump from dry running.
