**Ray's Well Testing Service Inc.**  
 4853 Vine Hill Rd, Sebastopol Ca 95472  
**Phone** 707 823 3191 **Fax** 707 317 0057 **Lic#** 903708

REPORT #: 11759-2 - By: Matt Owens	DATE OF TEST: 3/30/20
CUSTOMER NAME: Anna J. Jensen	CONTACT:
AGENT NAME: Karl Bundesen - Century 21	CONTACT: 707 769 9000
PROPERTY ADDRESS: 3501 Middle Rd, Petaluma CA 94952	SENT TO: karl.bundesen@bundesen.com

LOCATION OF WELL:	Domestic Well - Down hill from house near storage tank
TYPE OF WELL:	Drilled
DEPTH OF COMPLETED WELL:	Probe stopped at 100 Feet at top of pump
DIAMETER OF WELL CASING:	8" I.D. Steel
SANITARY WELL SEAL (PLATE SEAL AT OPENING OF WELL CASING):	Yes
ANNULAR SEAL (IN-GROUND SEAL OF BOREHOLE):	Unknown - Please Refer to well log
PUMP HP AND TYPE:	3/4 HP 230V Submersible, 1.25" Sch. 80 pipe, #12-4 cable
DEPTH OF PUMP SUCTION:	100 Feet

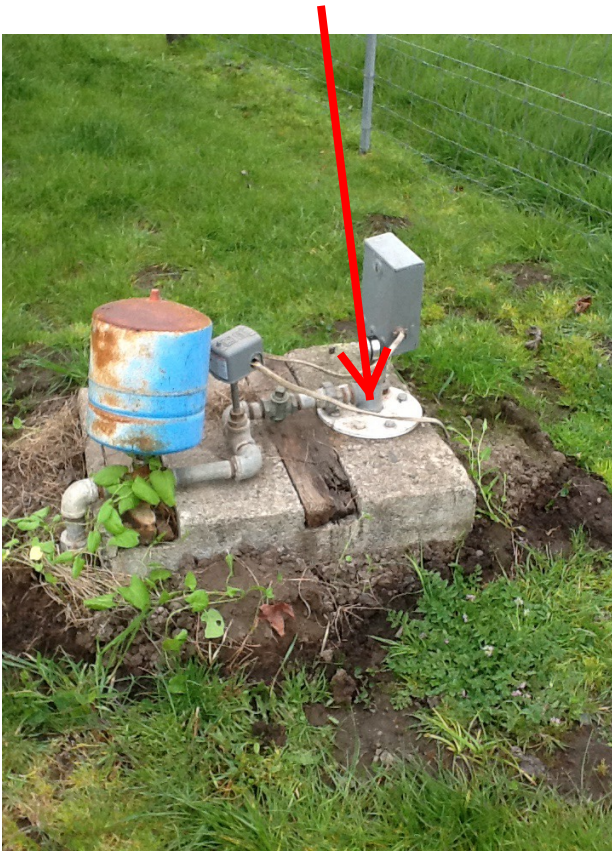
Well Head

4. There is no check valve at the well head. Recommend installation of a check valve.
5. The booster pump is not protected from dry running. Recommend installation of a dry run control device.

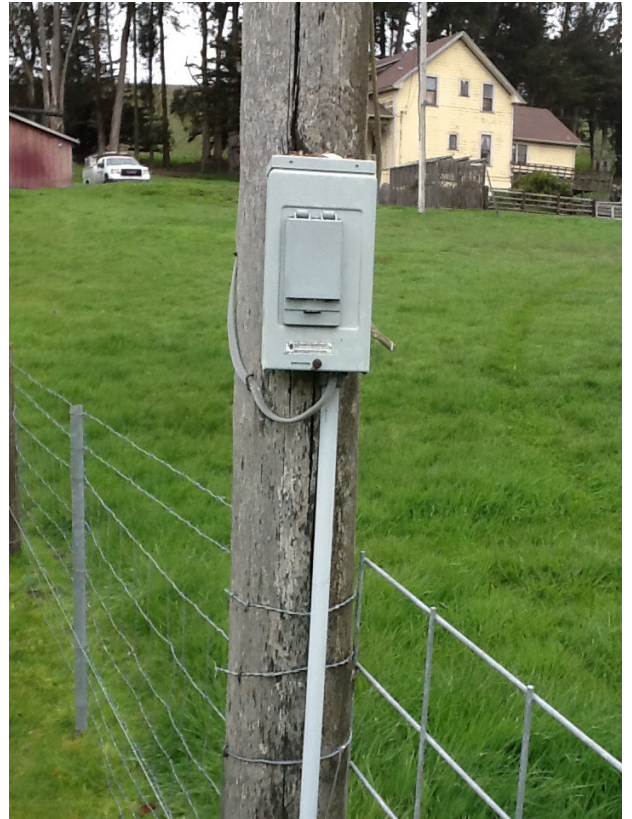
Electrical Sub Panel

WELL PUMP	Functional	TECHNICAL INFO: 14.1 GPM @ 70 PSI @ 20', 8.6 amps, control box dated 2017
ELECTRICAL	Functional	TECHNICAL INFO: 20 amp breaker in sub panel at well
PRESSURE TANK	See Comments	TECHNICAL INFO: See Comments
STORAGE TANK	Functional	TECHNICAL INFO:
BOOSTER PUMP	Functional	TECHNICAL INFO:

3. The well, booster, and agricultural pumps all share a common circuit coming from an overhead service. Recommend installation of a sub panel, individual circuit breakers for all systems and running buried conduit to eliminate hazard from the overhead service.

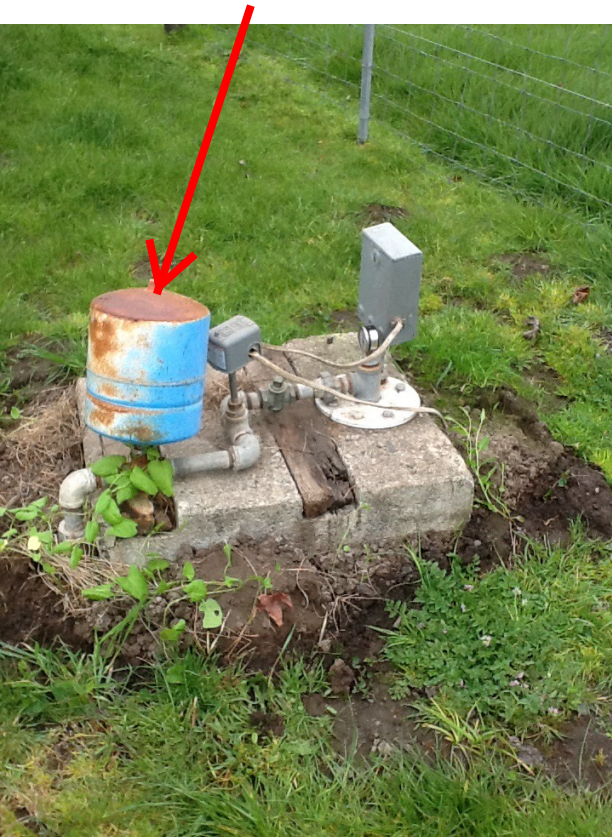
Well Pump Pressure Tank

5. The well pressurizes the 2 gallon WX-101 pressure tank (0 PSI air charge, partially waterlogged). The operating pressure range is set 40 to 60 PSI. This system pressurizes water to fill the 8000 gallon concrete storage tank. The tank fill is controlled by a mechanical float valve in the tank. The water in the tank was very cloudy. The well pump is protected by a Pumpsaver 231 device with the delay timer set to 50 minutes. The storage tank is weeping water from several cracks.

1. The well pump pressure tank has failed. Recommend replacement or converting the well to fill with a relay and electric float switch.
2. There are multiple exposed romex wires powering the well and booster pumps. Recommend installation of conduits to protect wires.

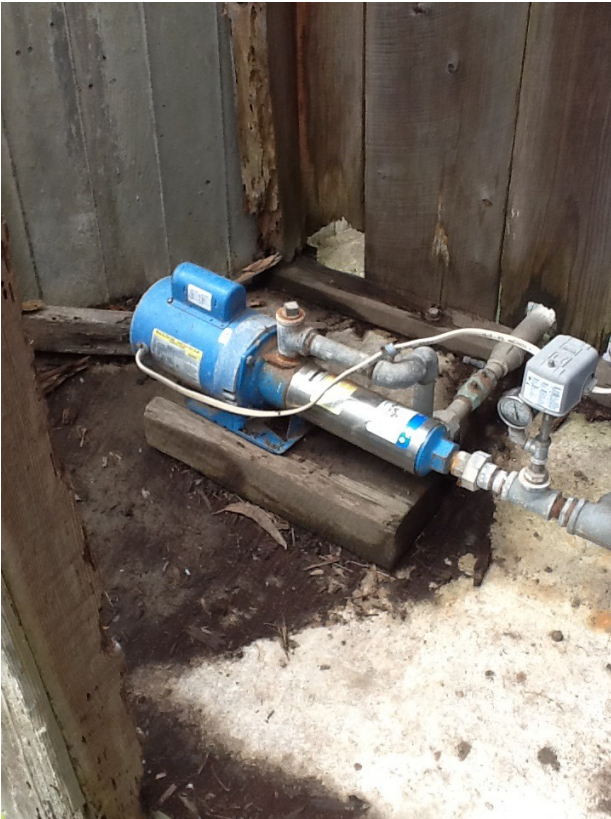
Booster Pump

6. The 1 HP 230V Goulds 25GBC10 booster pump draws water from the storage tank and pressurizes the 119 gallon Water Worker HT119B pressure tank (2017, 33 PSI air charge). The operating pressure range is set 40 to 55 PSI. This system pressurizes water for domestic use only. The suction line to the booster pump is plumbed to keep a 3000 gallon reserve in the tank for emergency use.

6. There is not a pressure relief valve on the booster system. Recommend installation of a pressure relief valve.
7. The water tests indicate presence of bacteria. Recommend disinfection of water system and installation of domestic treatment system.
