Re: Report of septic system evaluation at 3501 Middle Road in Petaluma, CA 94952
Assessor Parcel Number: 100-020-17

I conducted a septic system evaluation on March 25, 2020 at 12:00 p.m. I found the following:

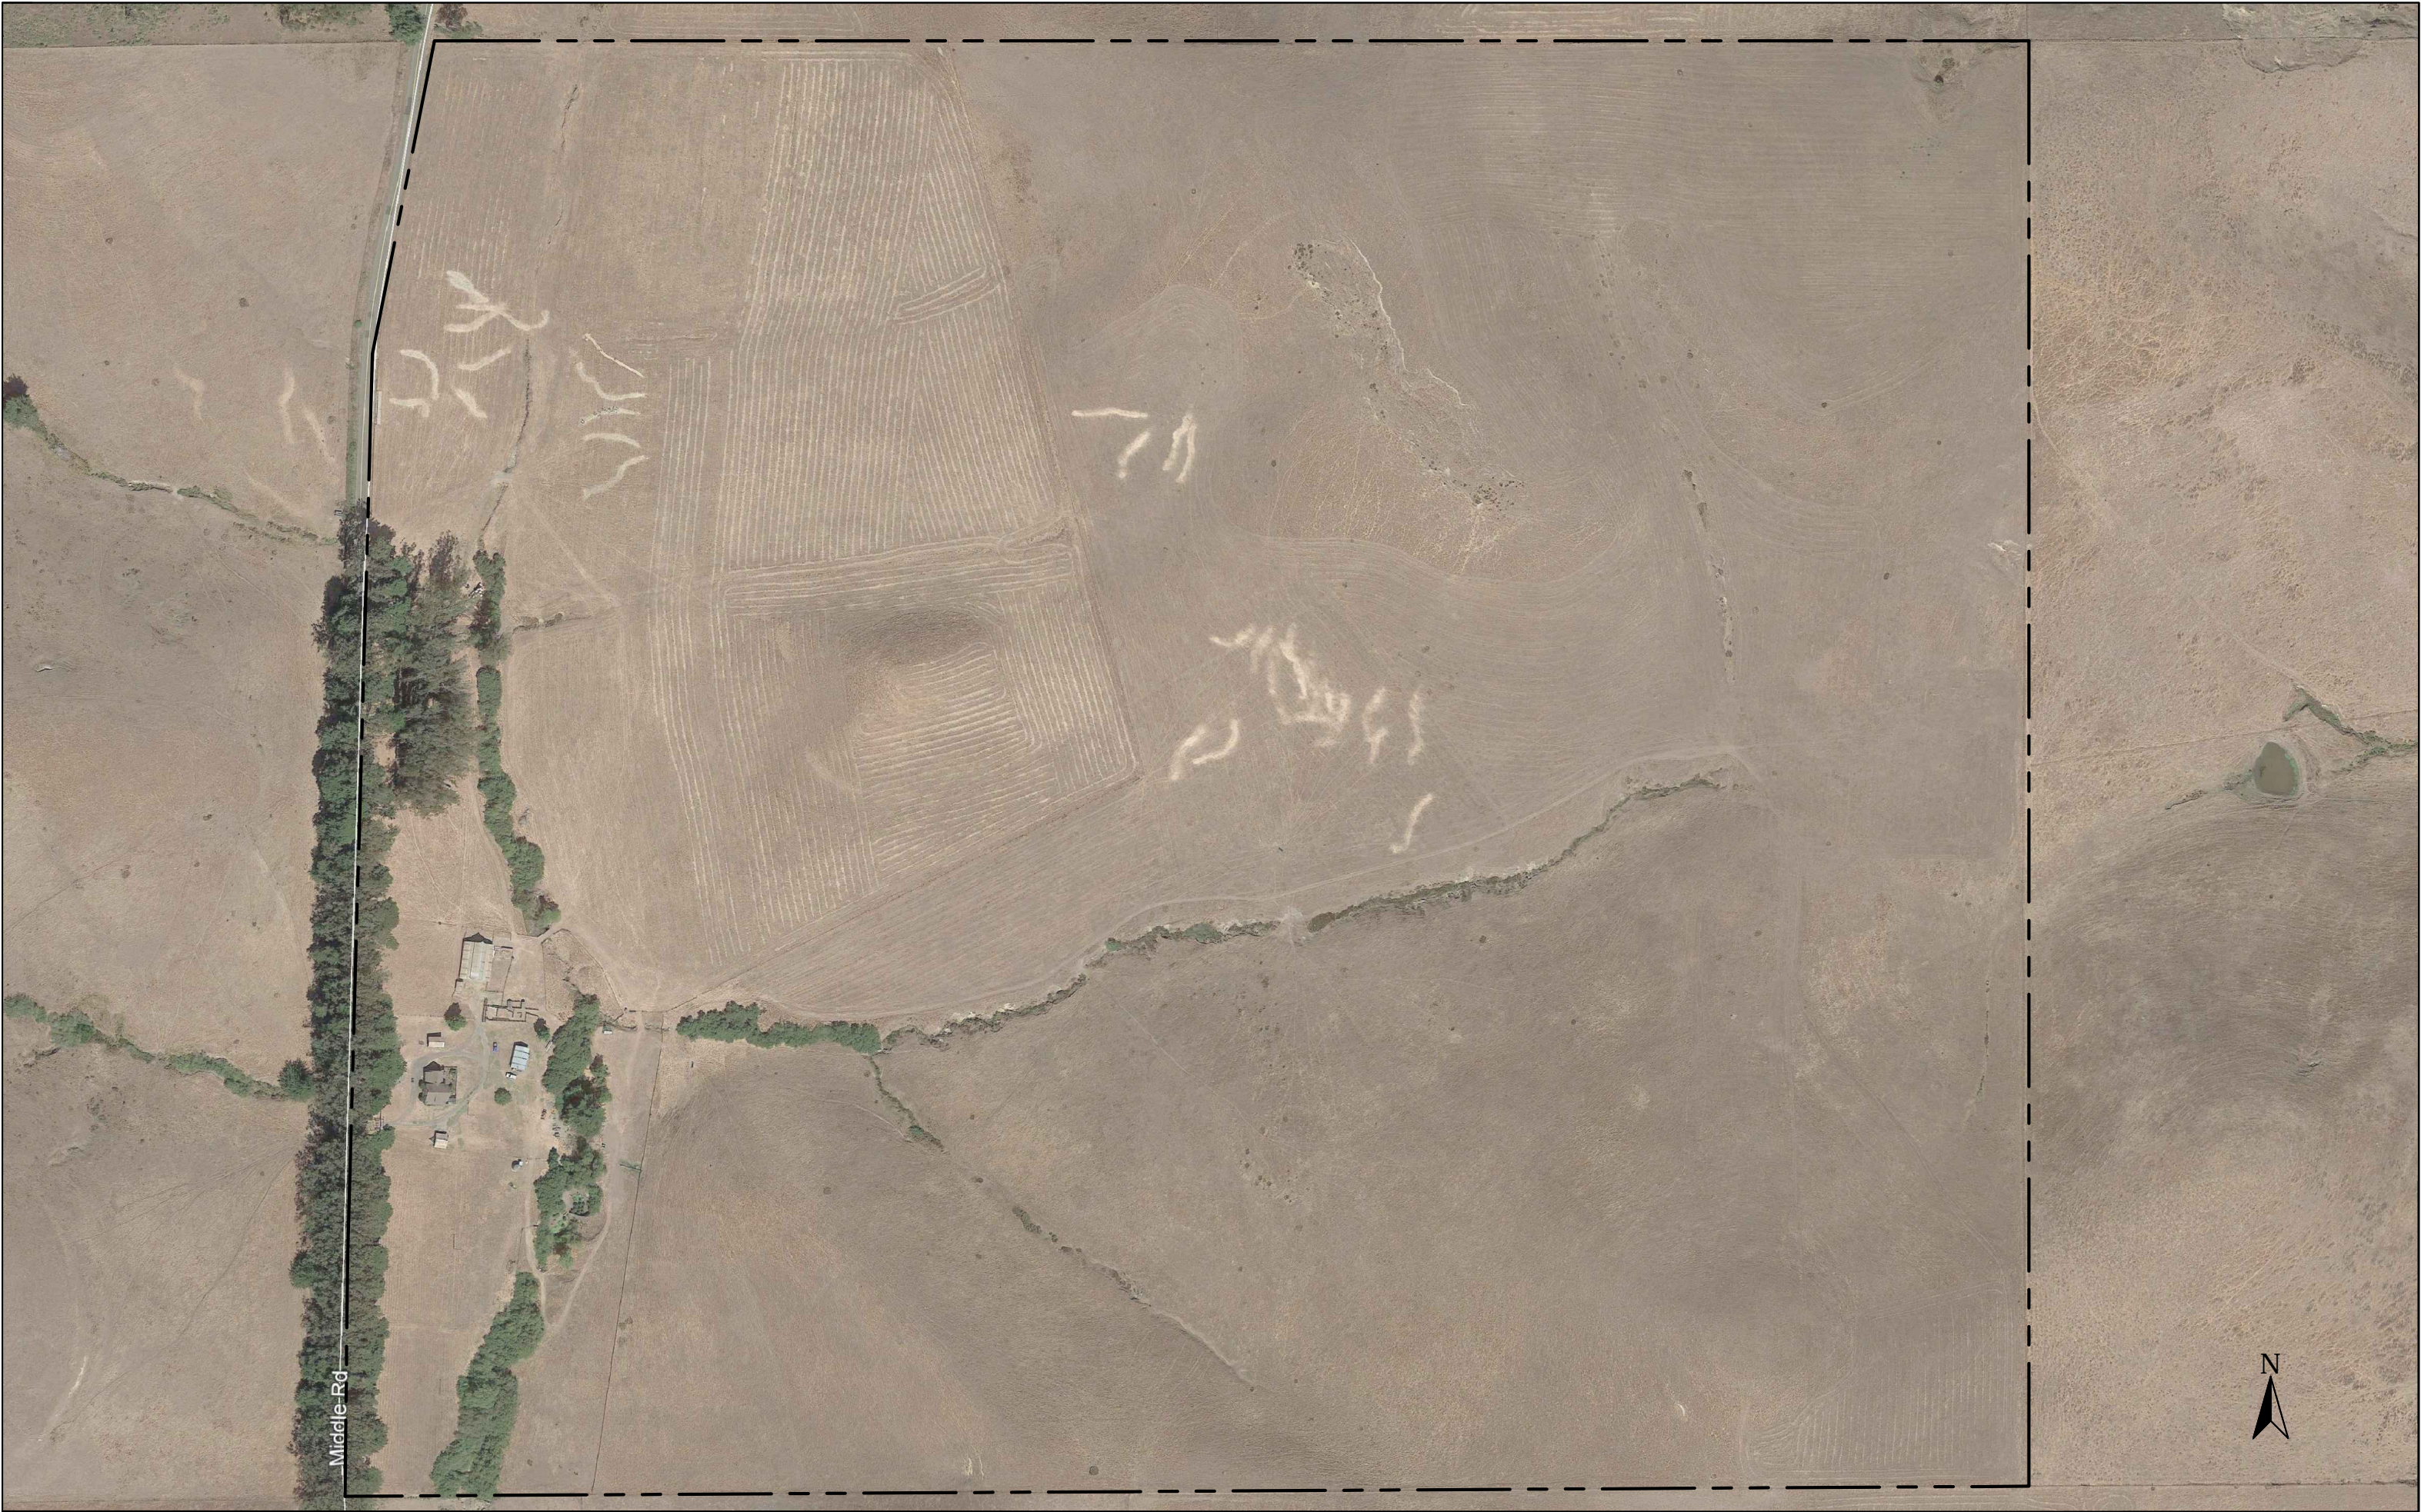
4. The leach lines were not exposed during my site visit. Therefore, the precise location, number of leach lines, and lengths of leach lines are unknown. I walked the approximate leach field based on information from the property owner. I observed and found neither sign of lush vegetation, green stripes, foul odor, wet area, nor past failure within and near the leach field. I also didn't find any erosion, cuts or fill near leach field, or vehicle paving over the leach field. I conducted a

AREA WALKED
AND OBSERVED

5. There is a potential reserve area on the parcel, see attached area map. The type and size of the new septic system will depend on the current codes at the time of replacement.

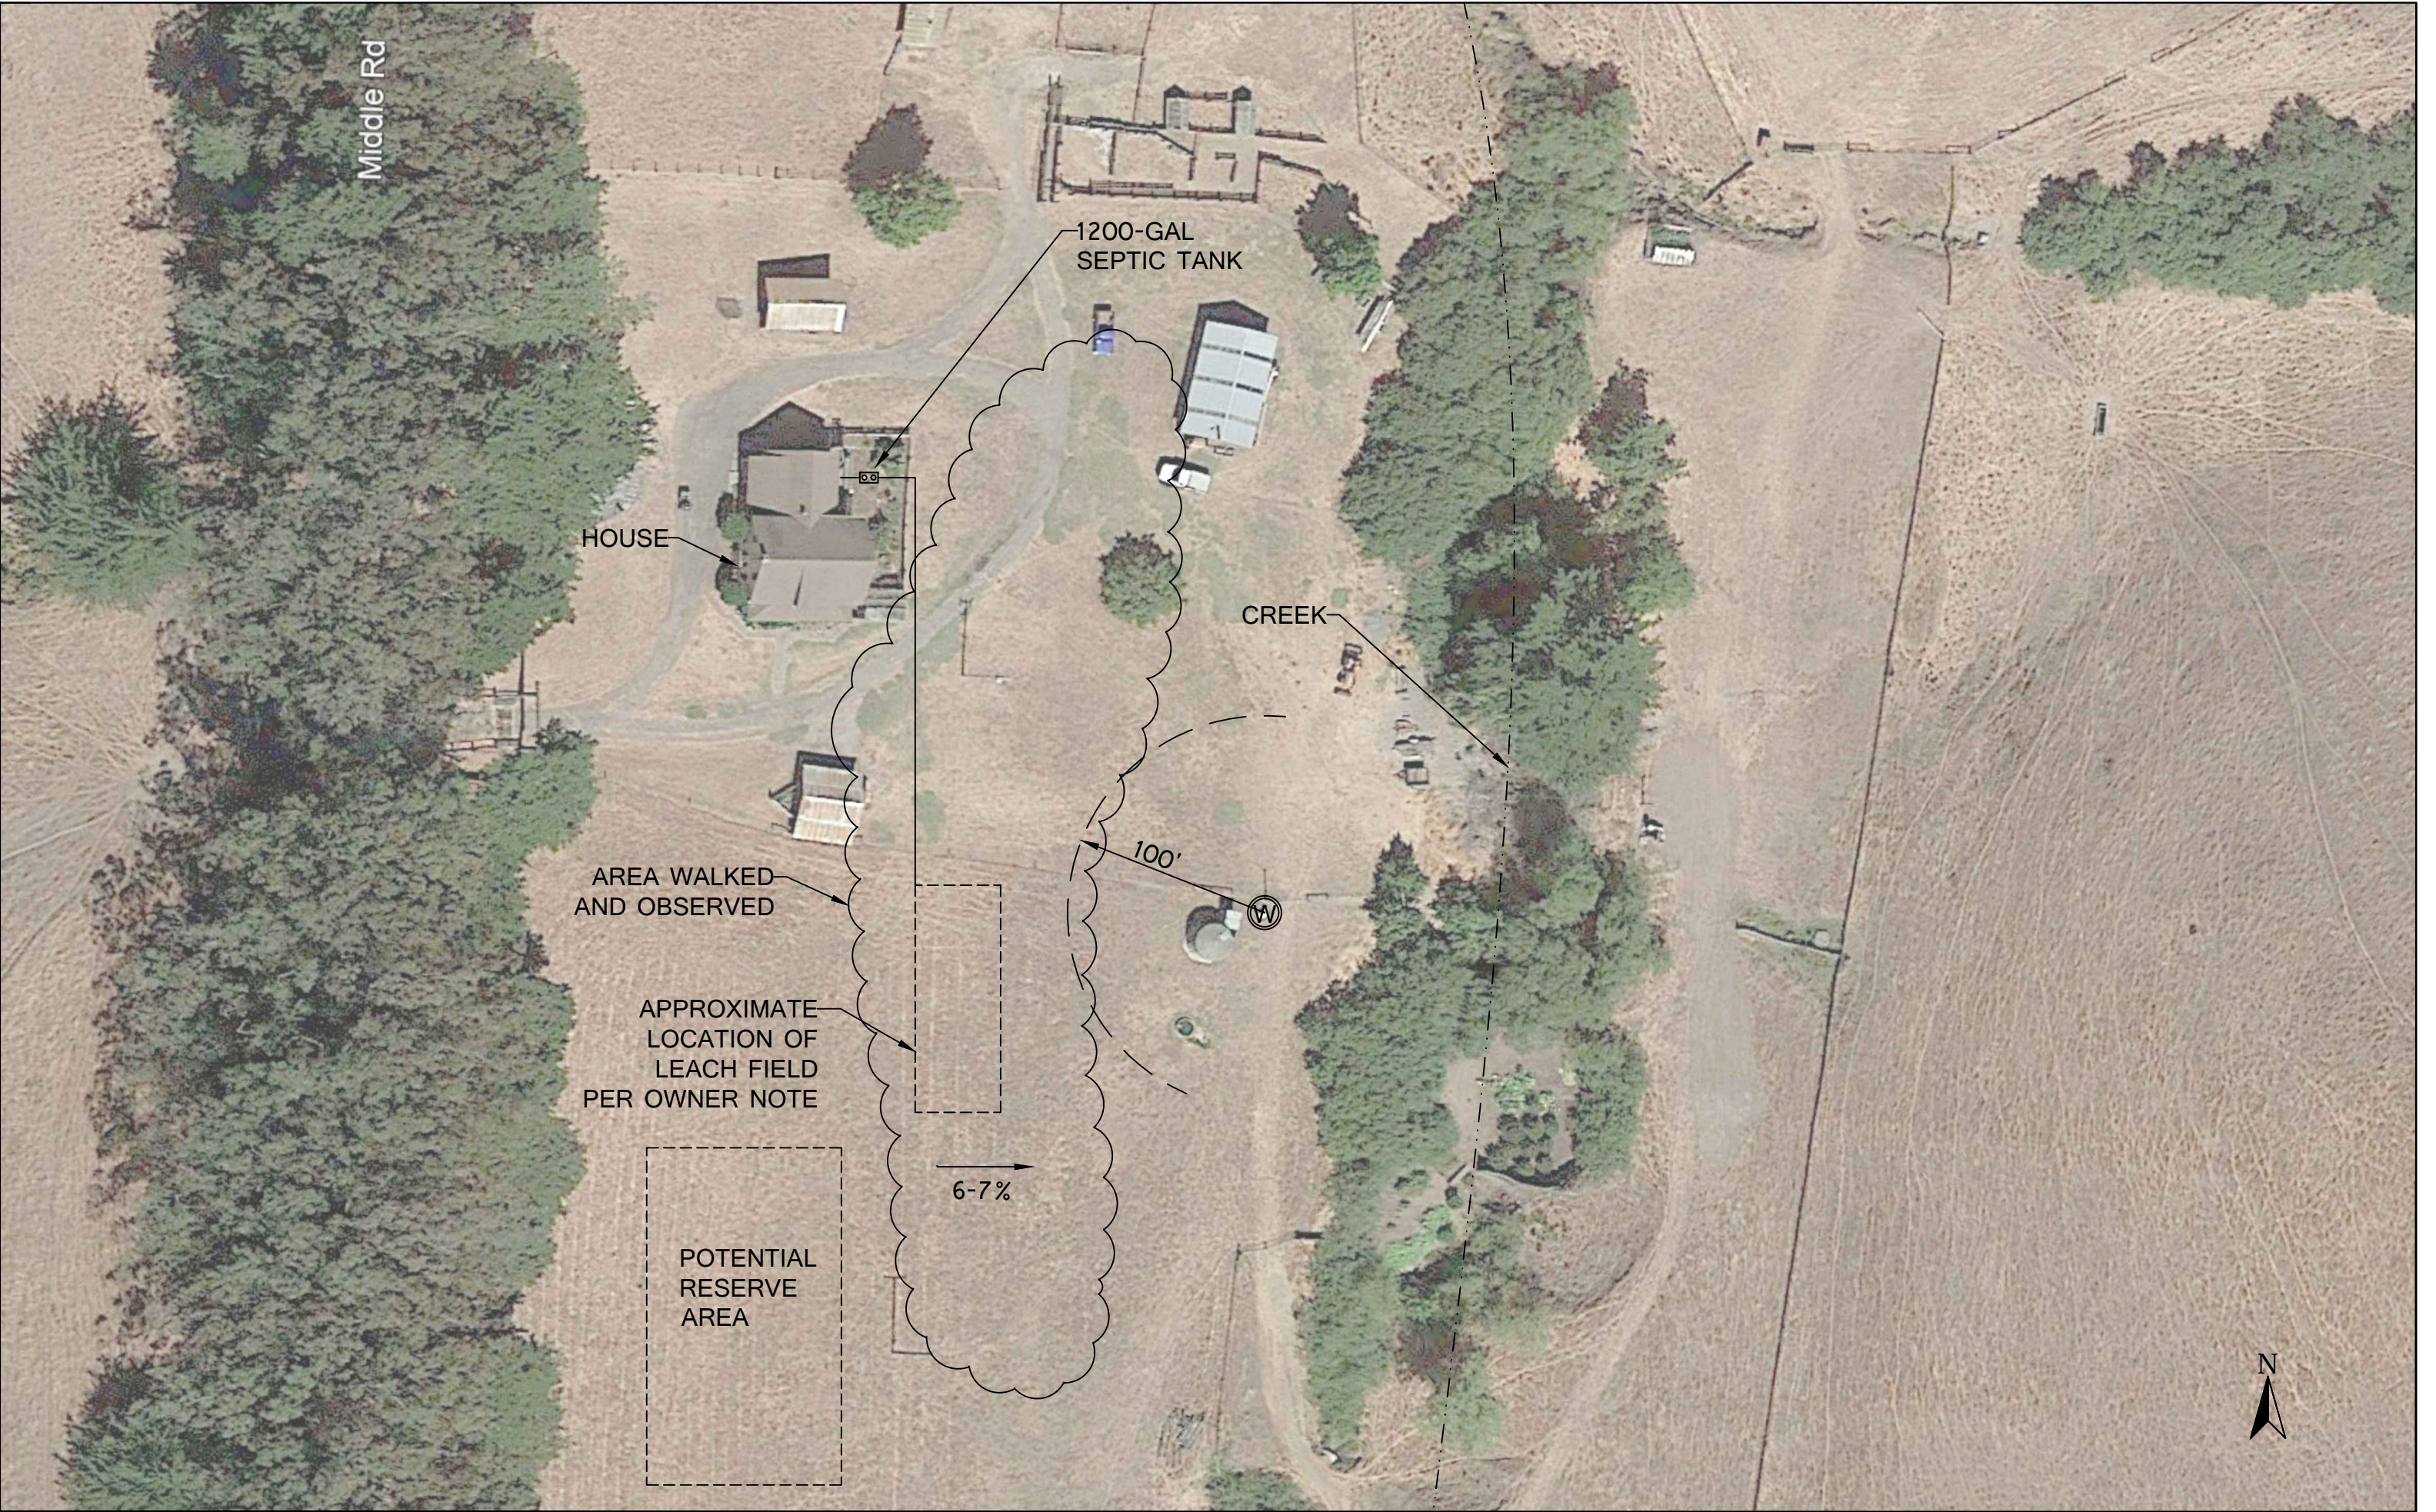
1200-GAL
SEPTIC TANK

HOUSE

CREEK

APPROXIMATE
LOCATION OF
LEACH FIELD
PER OWNER NOTE

POTENTIAL
RESERVE
AREA
